Enclosed are field notes regarding slide @
M.P. 7 near Quendall, WA.

Subject: Evaluation of Railroad Embankment Repairs
(b) (6) Residence Slide Area
Bellevue, Washington

Subject: Railroad Embankment Repair Observations
Adjacent to (b) (6) Residence
Pleasure Point Area
Bellevue, Washington

Subject: Preliminary Assessment of Slide Damage
(b) (6) Residence
Pleasure Point Vicinity
Bellevue, Washington

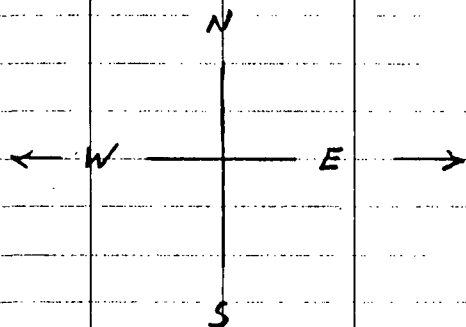
KENNYDALE, WA
SLIP OUT MP 7.21

PT. 1 @ STA. 887+77.11

FROM ASSUMED CULVERT STATION 897+59.50

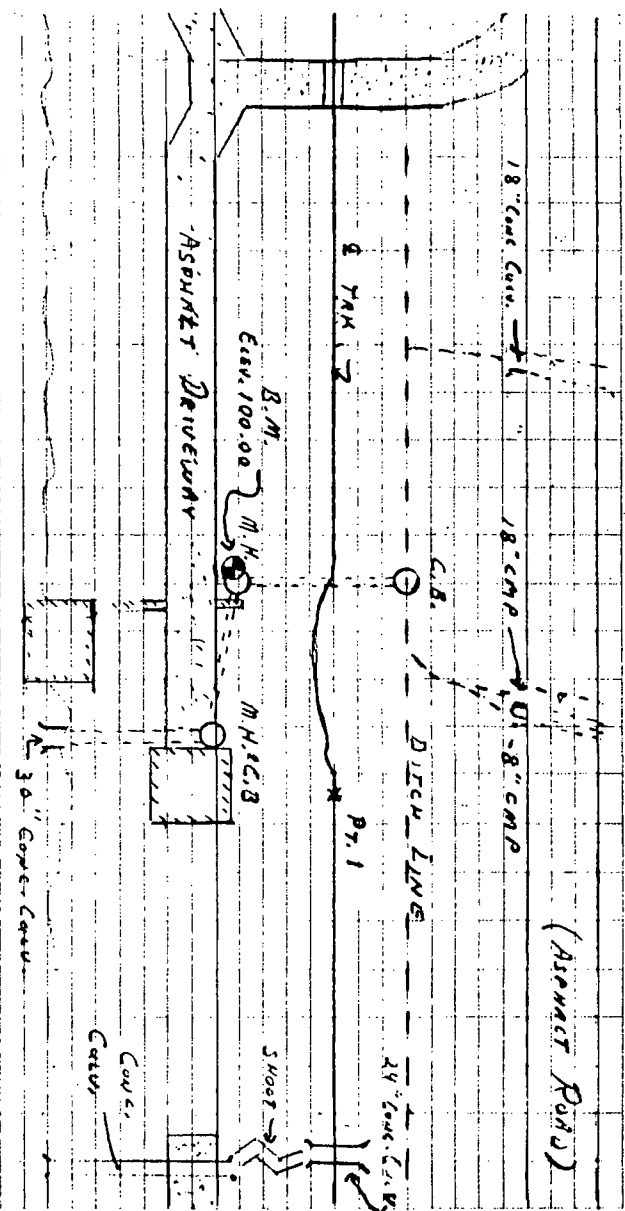
4

LAKE WASHINGTON
